**US Airways Flight 1549
A320-214 N106US
Landing in the Hudson River
Weehawken, New Jersey
January 15 2009**

Accident Investigation

AIRBUS S.A.S

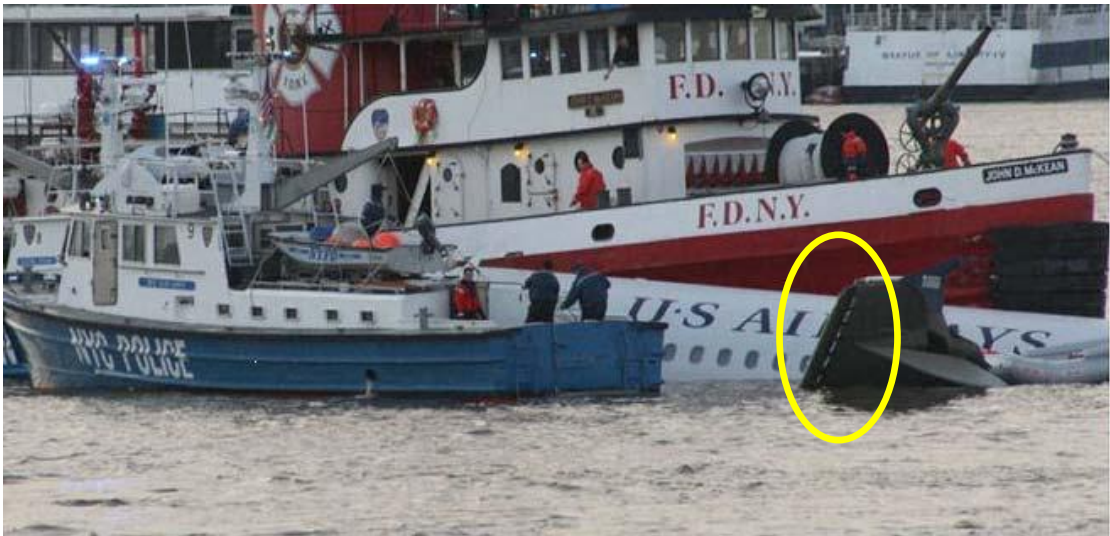
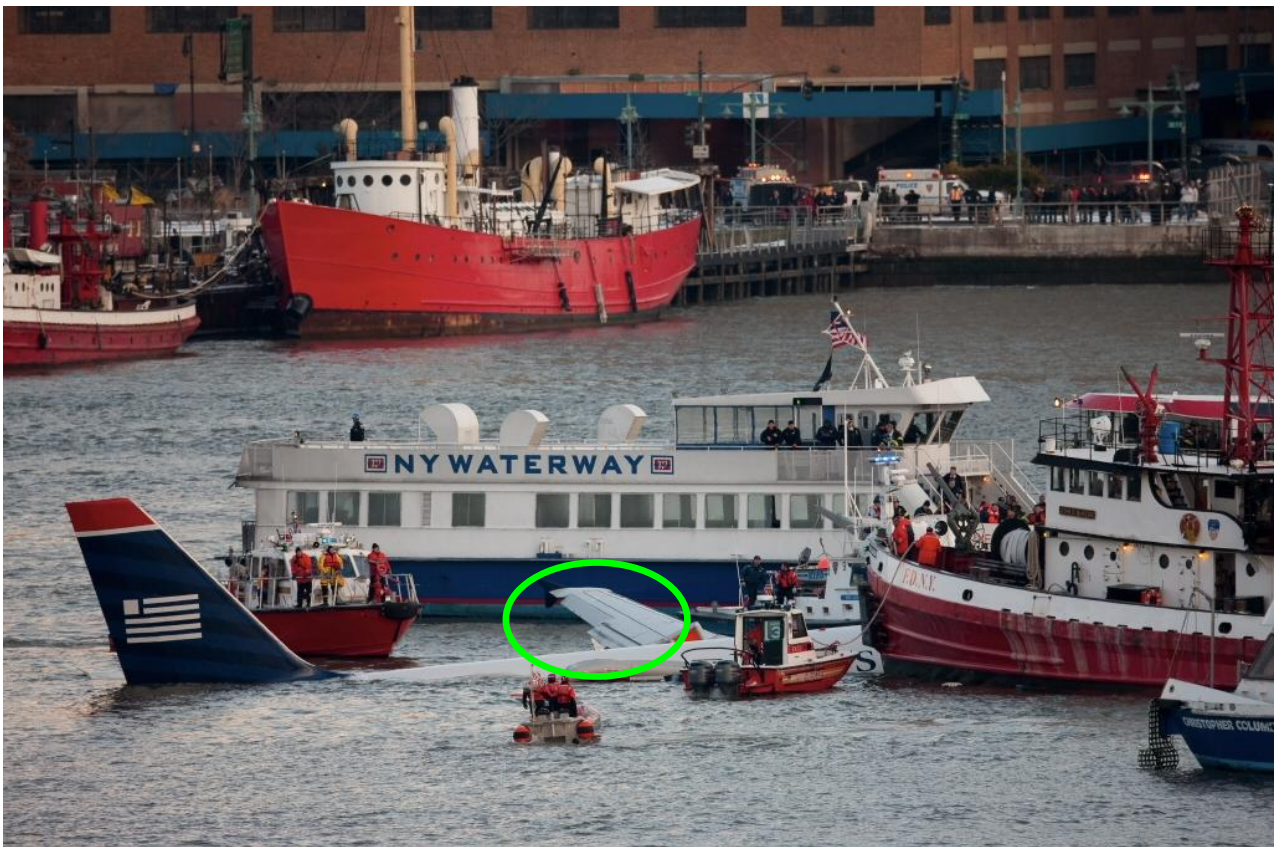
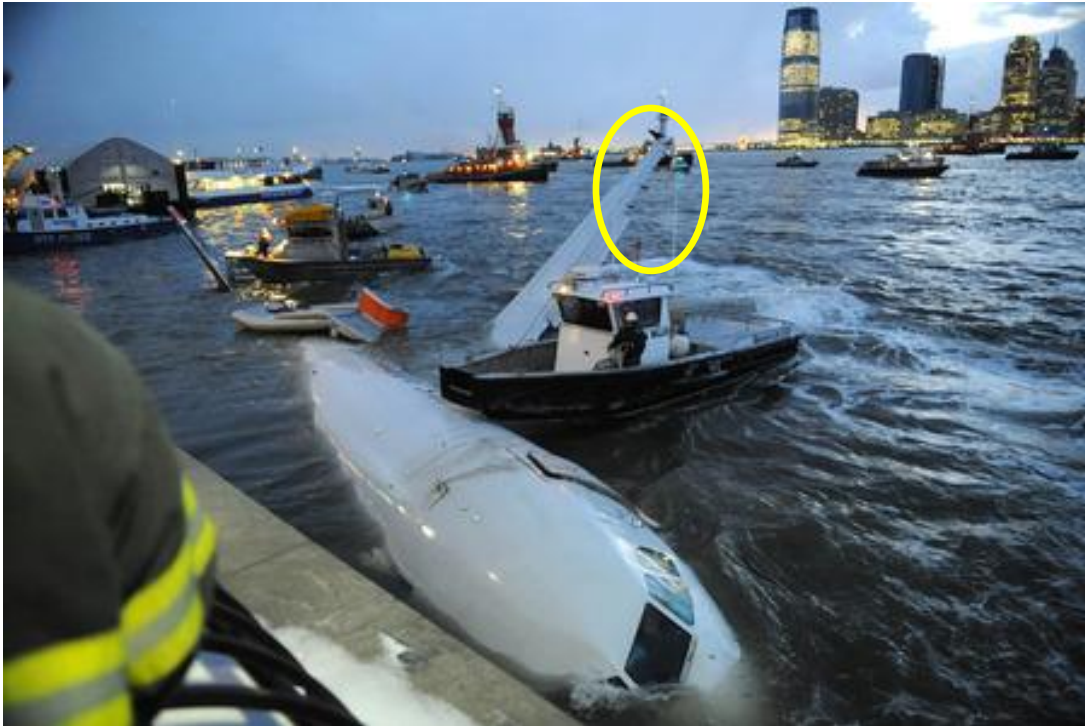
During the rescue operation, the Aircraft suffered multiple damages due to impacts from rescue and later towing boats.

For example, the following pictures clearly show that the left wing outboard slat and flap were still present after the emergency landing on water, while it was later completely destroyed after the towing operations.

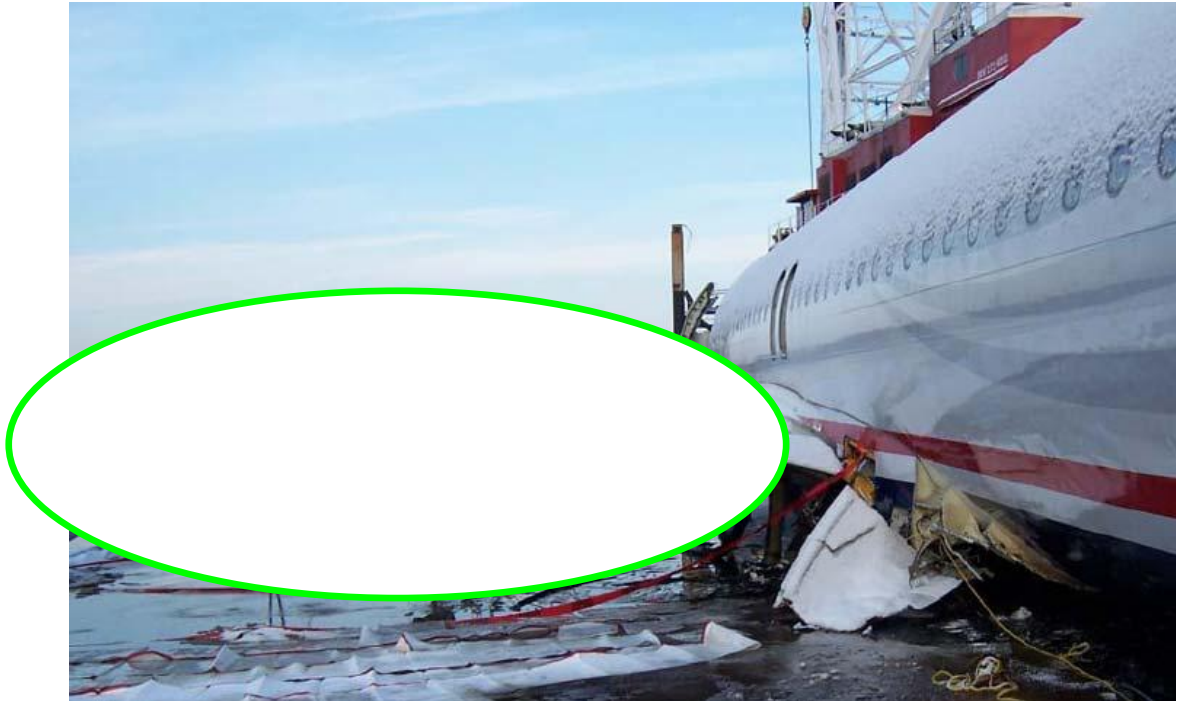
The right engine remained attached to the wing and the left engine separated from the wing during the unplanned emergency water landing. The horizontal and vertical stabilizers and portions of the movable control surfaces remained attached to the Aircraft. The nose and main landing gears remained retracted and attached to the Aircraft. The fuselage and wings experienced multiple bird strikes, and sustained damage during the unplanned water landing and recovery phase.

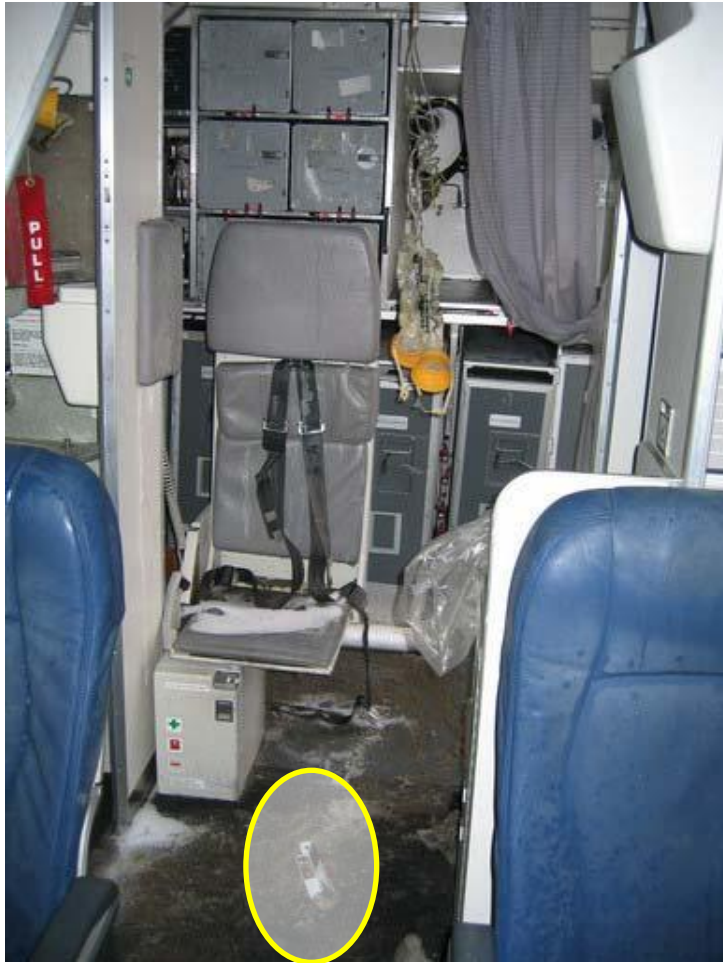
In front of the aft swivel cabin attendant seat, a 4 ¾ inch portion of the frame 65 vertical beam was protruding through the cabin floor

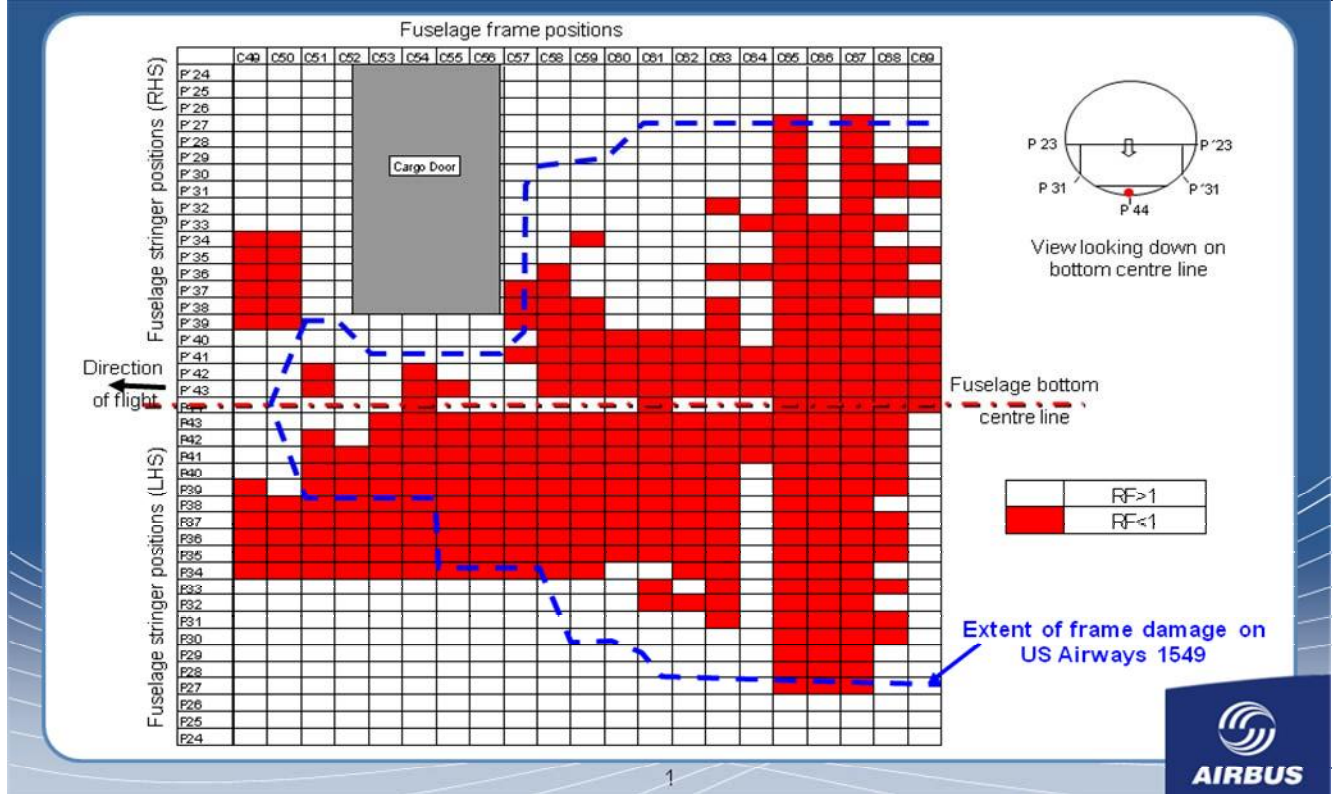
Frame Reserve Factors For External Pressure During Emergency Water Landing (US Airways Flight 1549)

The corresponding external pressures for Flight 1549 emergency landing on water were estimated, and the reserve factors for the rear fuselage were calculated for this new loadcase. Each area for which the computed reserve factor is less than one are shown in red on the following drawing

This is relatively well matching with the actual structure damage observed on the Aircraft.

This analysis gives an estimate for the initial frame failure only; subsequent post-failure effects such as water scoping are not taken into account.

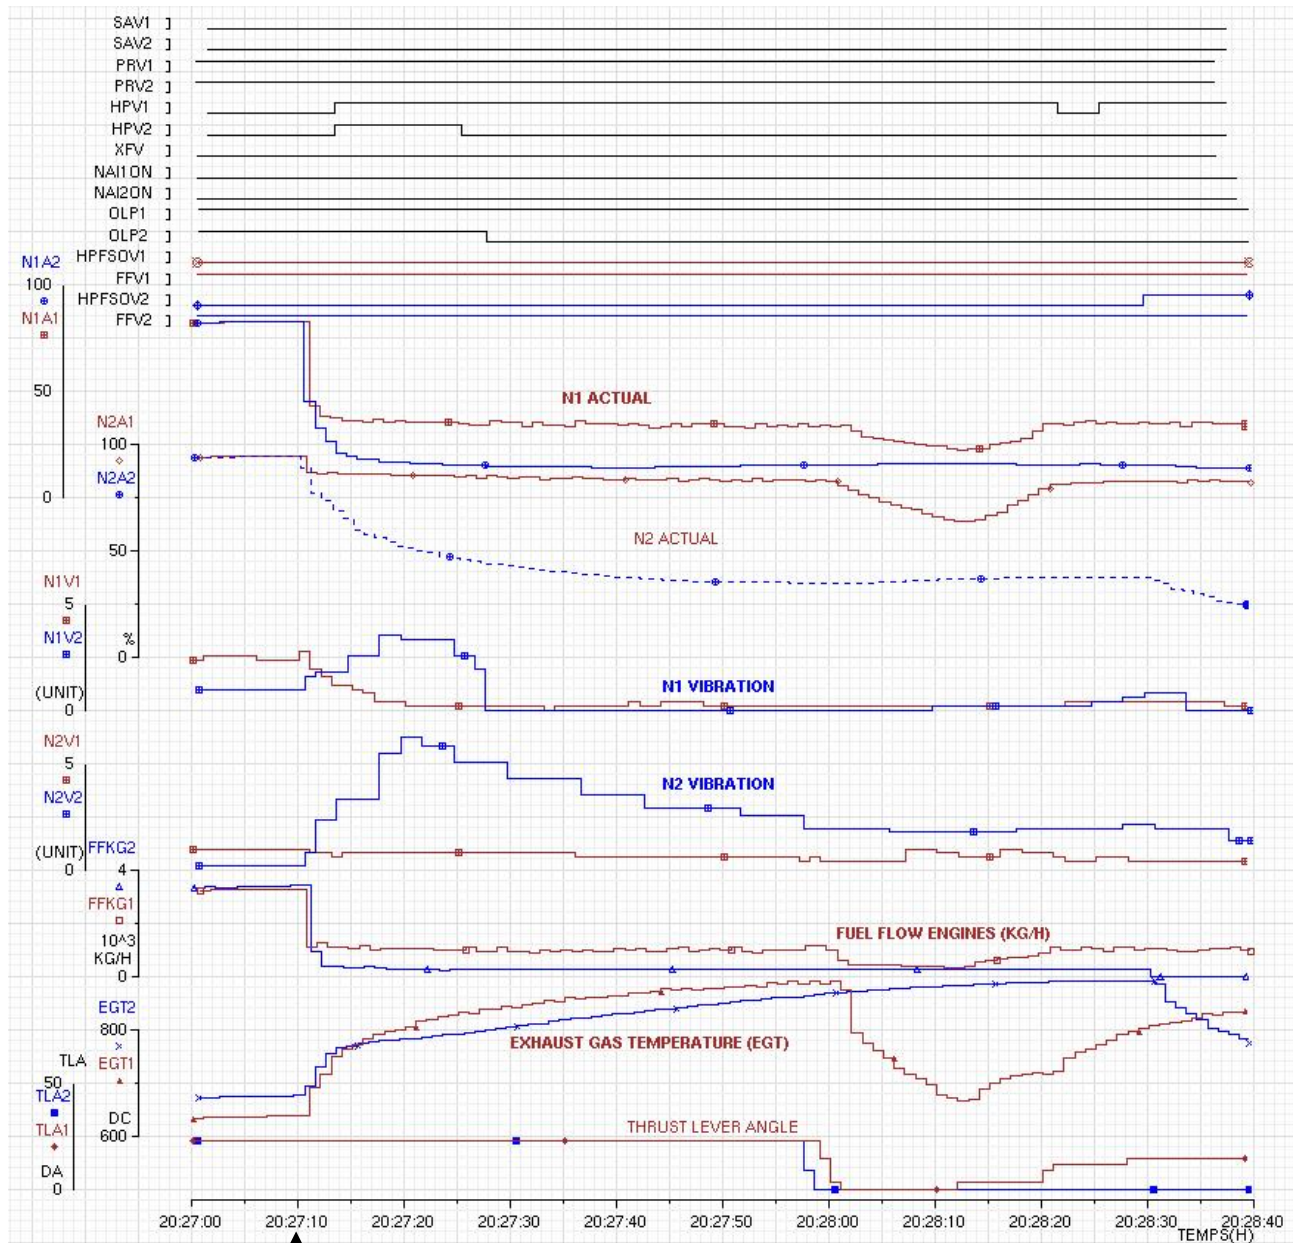
DFDR Data:

At 20:27:10, the DFDR indicates a sudden drop down recorded on N1 and N2 values for both engines:

Engine 1: N1 from 82% down to 35%, N2 from 94% down to 85%,
 Engine 2: N1 from 82% down to 14%, N2 from 94% down to 35%.

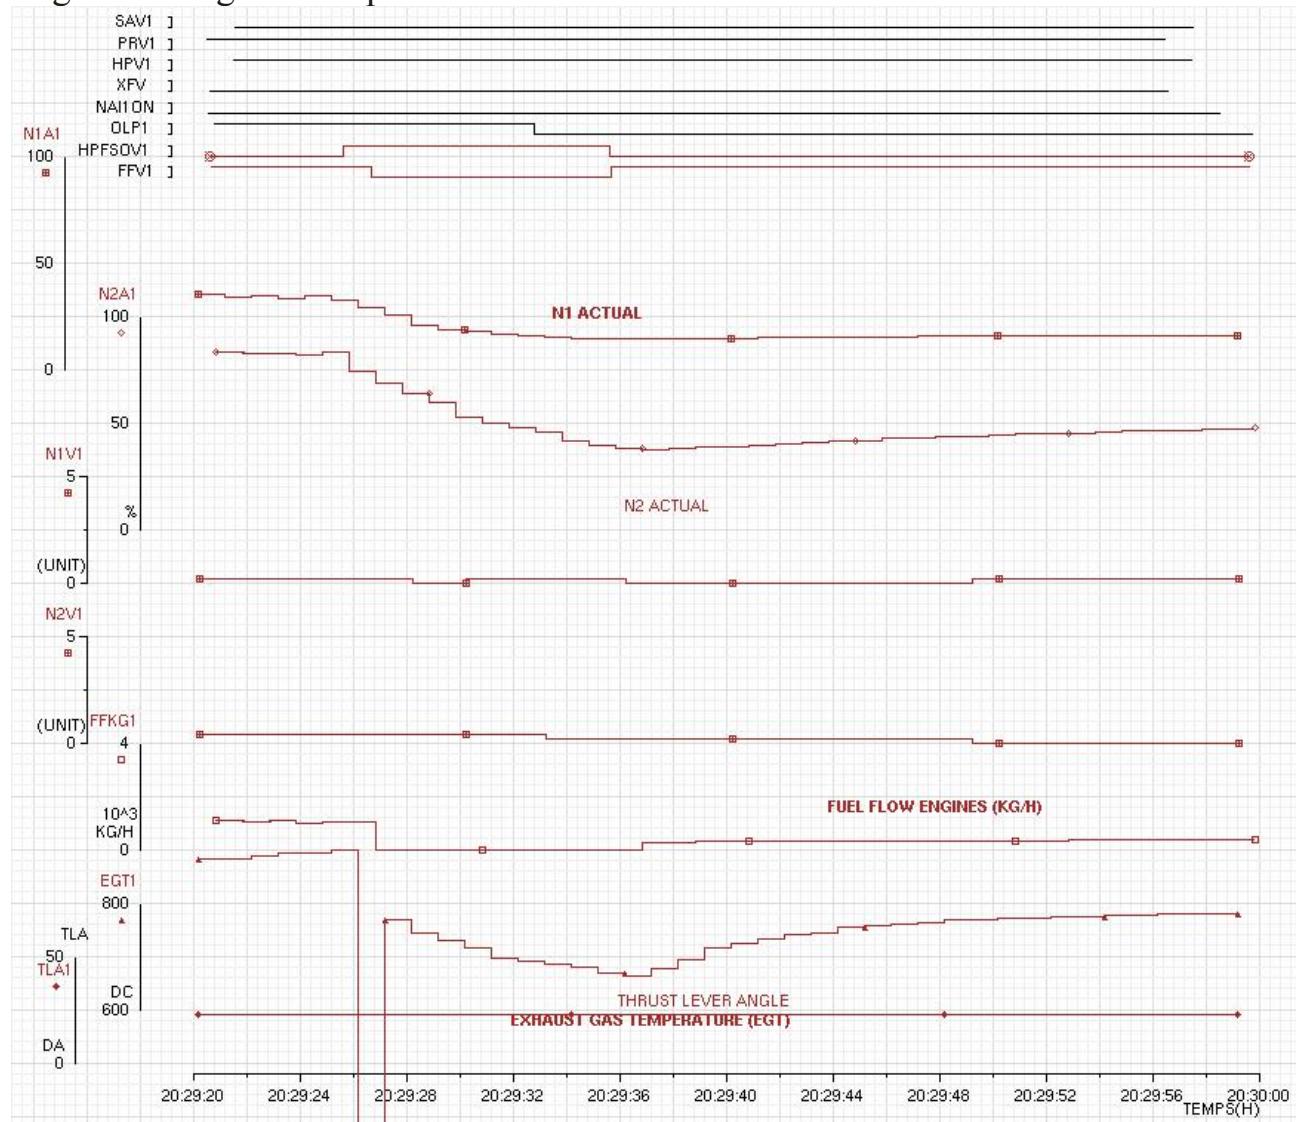
Engine 1 Relight Attempt

At 20:29:26, Fuel Fire Valve on Engine 1 recorded closed, and then Not Fully closed 9s later.

At the Fuel Fire Valve closure, a peak recorded on EGT1 parameter.

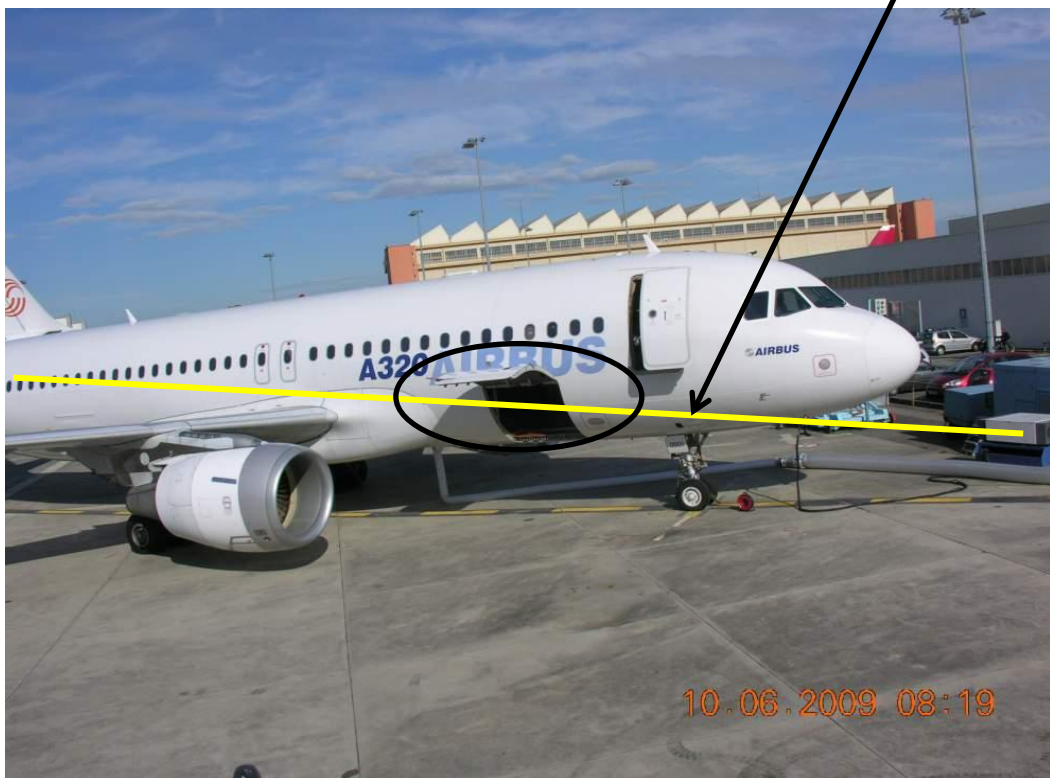
Water level
from above
picture
