**US Airways Flight 1549
A320-214 N106US
Landing in the Hudson River
Weehawken, New Jersey
January 15 2009**

Accident Investigation

AIRBUS S.A.S

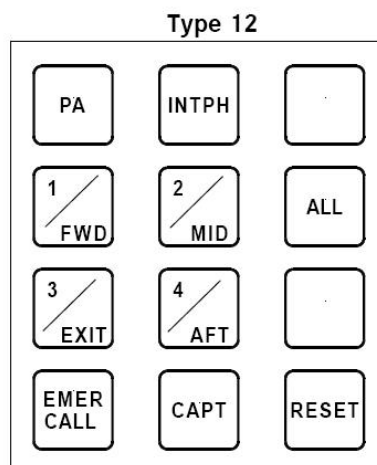
MSN 1044 cabin handset configuration.

For example, if a forward cabin crew wants to connect to the back of the cabin, the attendant has to press the button INTPH, and THEN the button 2/MID. See figure above.

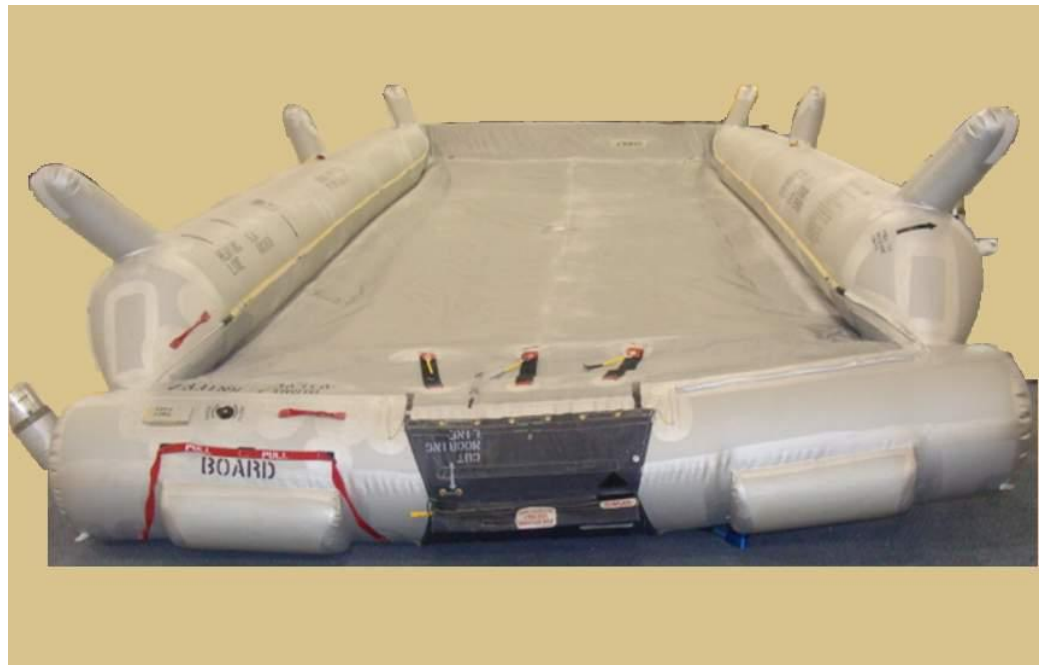
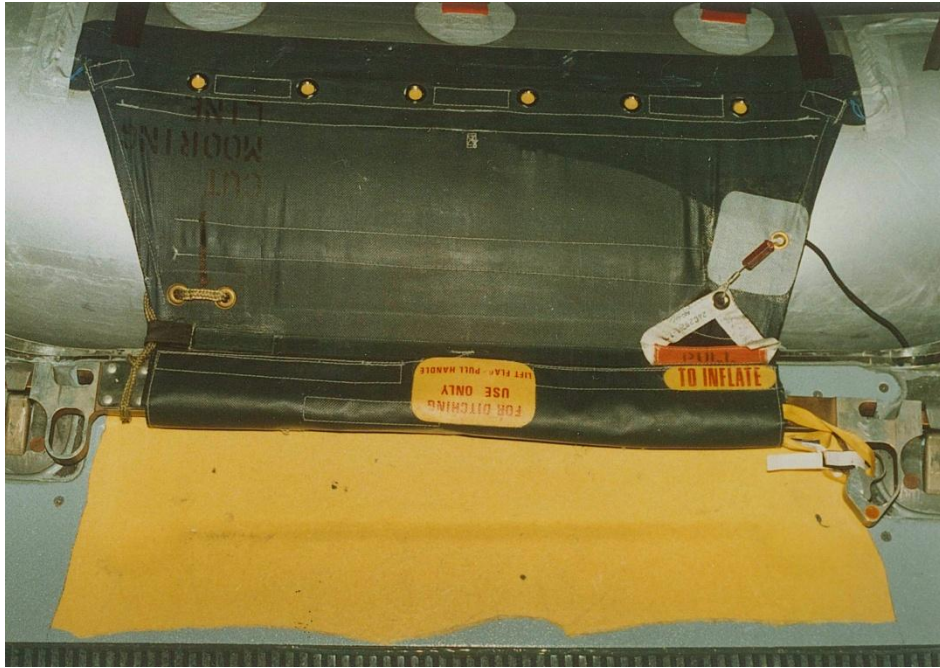
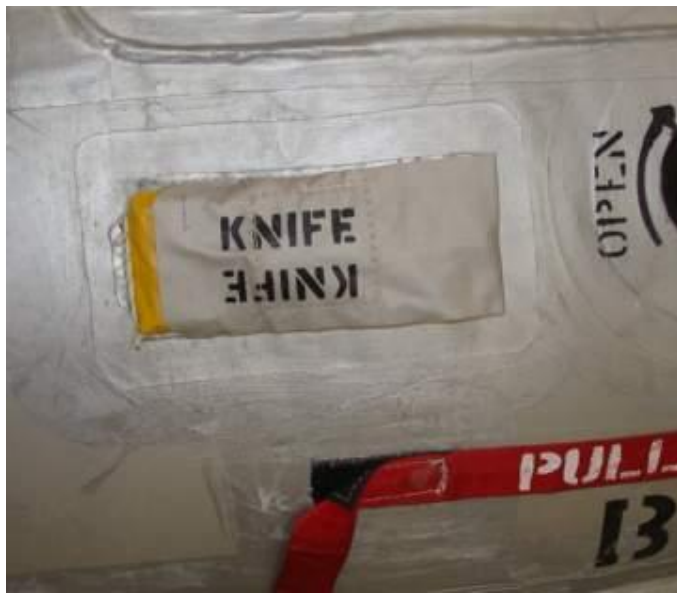
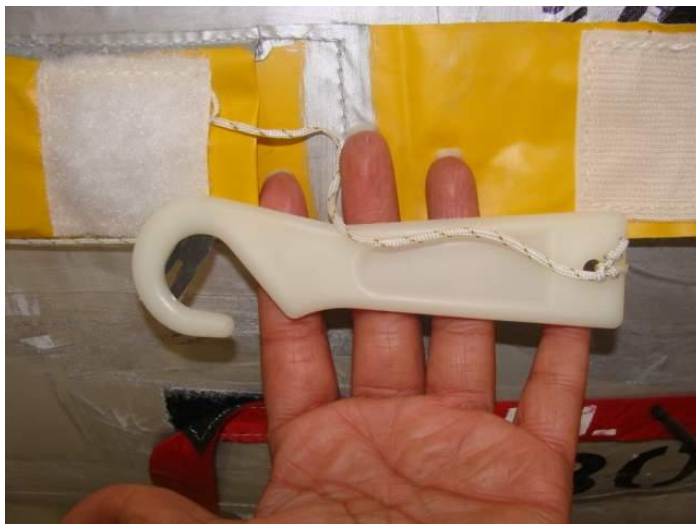
From flight and cabin crew interviews, the mooring line of both forward slide rafts was cut using a knife borrowed from the rescue ferries.

The mooring line is intended to be cut using the dedicated hook knife stored on the raft upper tube in a pocket, RH side of the girt when the raft is inflated. See figures below.

A “knife” inscription is placed on the hook knife pocket flap, and a “cut mooring line” inscription and an arrow designates the location where the mooring line has to be cut.

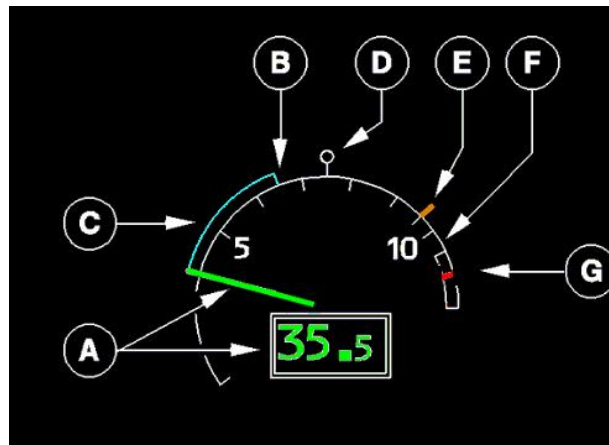
However should there be a delta between N1 actual and N1 command the blue arc is displayed between the two points. This provides an indication that the engine is not producing the commanded thrust but the engine is still producing power. In response to a bird strike or an engine compressor stall the flight crew would typically pull the throttle back and re-accelerate. The N1 response should correlate to the throttle position hence providing further feedback to the flight crew on the engine health and responsiveness to a power demand. CVR records do evidence that, on top of the physical perception of the Aircraft deceleration, the crew properly identified from the displays that both engines were rolling back.
